**Flood Control Project Maintenance  
Levee Inspections**

**Maintenance Issue Types Only, Levee Inspection Report By Mile - Fall 2016**

**Reclamation District No. 0544 Upper Roberts Island**

Waterway	Bank	Unit Miles	Inspection Start/End	Inspector
Unit No. 01 San Joaquin River	Left	6.05	10/12/2016 11/02/2016	Richard Willoughby

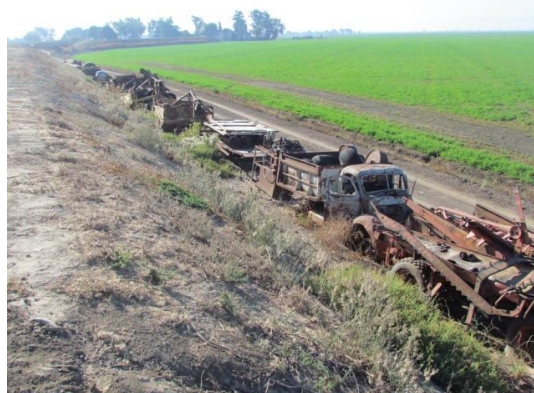
Photo 2 of 5 : FA\_2016\_RD0544\_108\_4\_20160929\_00005.jpg

Looking southwest at equipment stored at landward toe fall 2015.

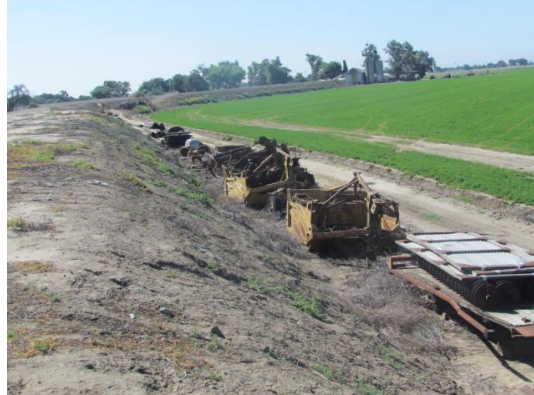
Photo 3 of 5 : FA\_2016\_RD0544\_108\_4\_20160929\_00006.jpg

Looking south at farm equipment at landward toe. (Spring 2015)

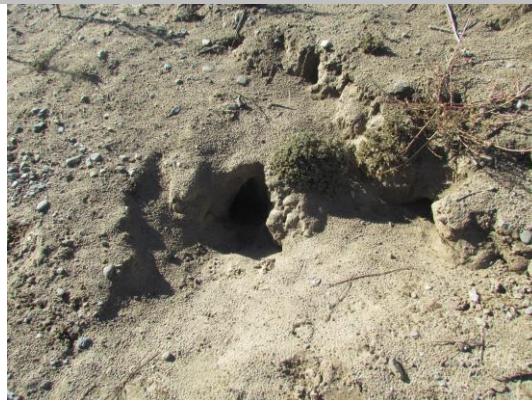
Photo 1 of 1 : FA\_2016\_RD0544\_108\_11\_20161107\_00142.jpg

LM Start	<b>3.92</b>	Rating **	U	Issue No.	<b>11</b>
LM End	<b>4.05</b>	Issue Type +	Ma	Location *	WS
Category	Earthen Levee		GPS Latitude/Longitude		
			Start	End	
Item	Animal Control		37.828078°	37.826315°	
			-121.311483°	-121.311024°	
DWR ID	DWR_RD0544_01_s_2012_11				
Comment Code					
A1 : Exterminate rodents and backfill and compact or grout burrows.					
Inspector Comment					
Large rodent holes on waterward slope.

Looking at large rodent holes on waterward slope.

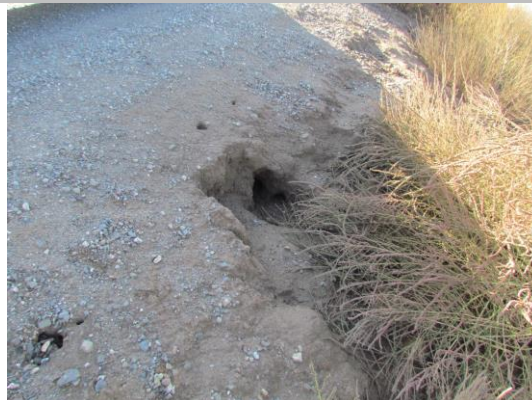
Photo 1 of 1 : FA\_2016\_RD0544\_108\_83\_20161107\_00145.jpg

LM Start	4.74	Rating **	U	Issue No.	83
LM End	4.74	Issue Type +	Ma	Location *	LS
Category	Earthen Levee			GPS Latitude/Longitude	
				Start	End
Item	Animal Control			37.821287 °	37.821287 °
				-121.320897 °	-121.320897 °
DWR ID	DWR_RD0544_01_f_2016_83				
Comment Code					
A3 : No rodents visible, but rodent burrows visible; need to backfill and compact or grout burrows.					
Inspector Comment					
Large rodent hole on waterward shoulder.

Looking at large rodent hole on landward slope.

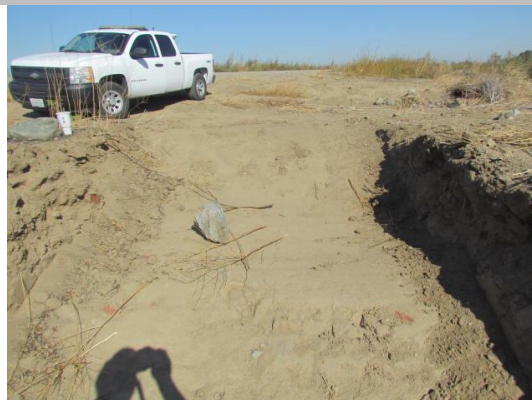
Photo 1 of 4 : FA\_2016\_RD0544\_108\_121\_20160929\_00076.jpg

Looking west at excavation on waterward berm.

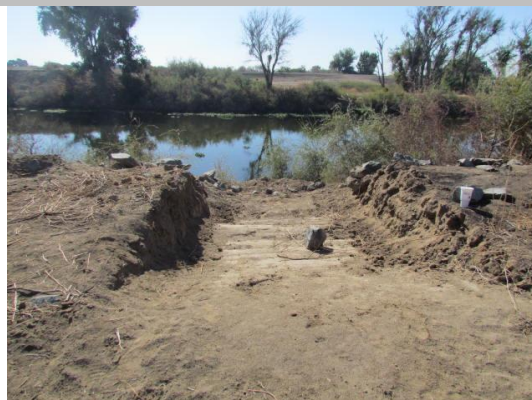
Photo 2 of 4 : FA\_2016\_RD0544\_108\_121\_20160929\_00077.jpg

Looking east at excavation on waterward berm.

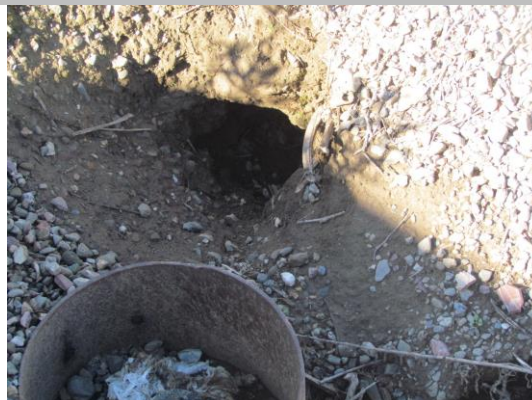
Photo 1 of 6 : FA\_2016\_RD0544\_109\_8\_20161107\_00086.jpg

Looking at hole next to siphon on waterward shoulder. (Fall 2016)

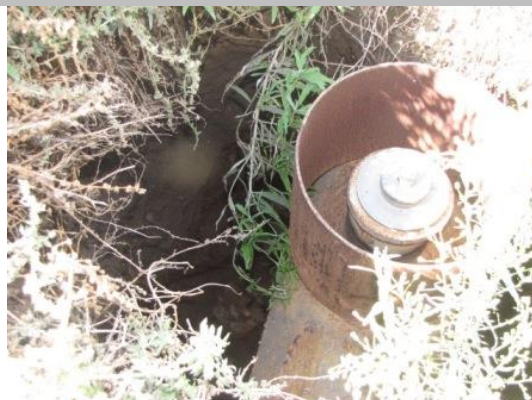
Photo 2 of 6 : FA\_2016\_RD0544\_109\_8\_20160929\_00008.jpg

Looking at caving around 10" siphon pipe on waterside shoulder.

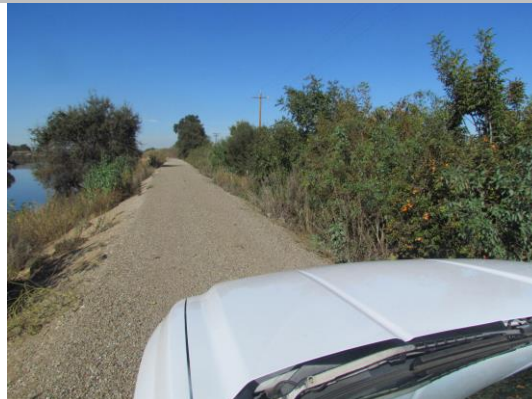
Photo 1 of 2 : FA\_2016\_RD0544\_109\_49\_20161107\_00087.jpg

LM Start	1.30	Rating **	U	Issue No.	49
LM End	1.40	Issue Type +	Ma	Location *	WS
Category	Earthen Levee			GPS Latitude/Longitude	
				Start	End
Item	Vegetation			37.820767 °	37.821582 °
				-121.336611 °	-121.338102 °
DWR ID	DWR_RD0544_02_f_2014_49				
Comment Code					
V2 : Remove the wild growth other than native grasses from the levee slopes.					
Inspector Comment					
Tobacco plants on waterward slope.

Looking southwest at dense veg on landward slope. (Fall 2016)

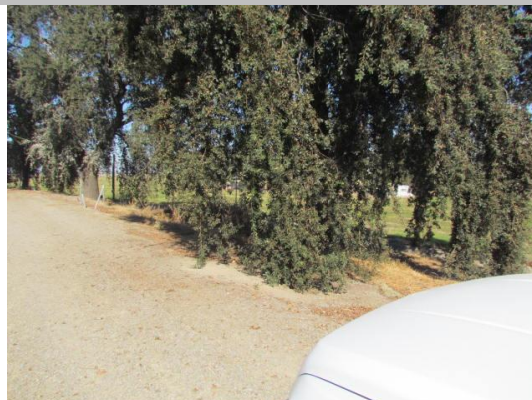
Photo 1 of 1 : FA\_2016\_RD0544\_109\_61\_20160929\_00052.jpg

LM Start	2.28	Rating **	U	Issue No.	61
LM End	2.28	Issue Type +	Ma	Location *	LS
Category	Earthen Levee			GPS Latitude/Longitude	
				Start	End
Item	Trim / Thin Trees			37.821473 °	37.821473 °
				-121.346860 °	-121.346860 °
DWR ID	DWR_RD0544_02_s_2015_61				
Comment Code					
T1 : Trim trees to at least five feet above ground level.					
Inspector Comment					
Untrimmed tree on landward shoulder.

Looking west at untrimmed trees on landward slope fall 2015.

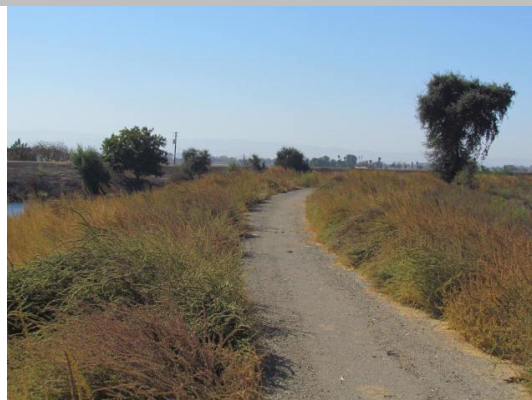
Photo 1 of 1 : FA\_2016\_RD0544\_109\_43\_20160929\_00040.jpg

LM Start	2.71	Rating **	U	Issue No.	43
LM End	3.05	Issue Type +	Ma	Location *	LS
Category	Earthen Levee			GPS Latitude/Longitude	
				Start	End
Item	Vegetation			37.817747 °	37.817497 °
				-121.351578 °	-121.357490 °
DWR ID	DWR_RD0544_02_s_2012_43				
Comment Code					
V2 : Remove the wild growth other than native grasses from the levee slopes.					
Inspector Comment

Looking at dense vegetation on landward and waterward slope.

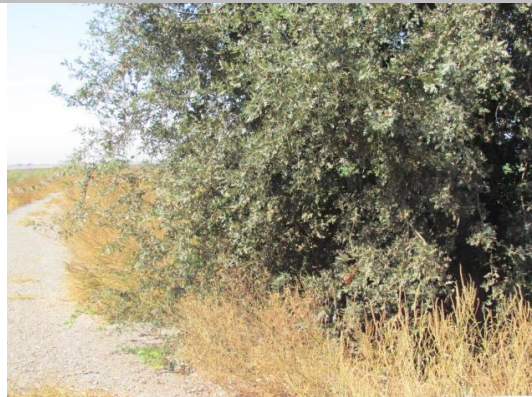
Photo 1 of 1 : FA\_2016\_RD0544\_109\_53\_20160929\_00047.jpg

LM Start	2.80	Rating **	U	Issue No.	53
LM End	2.80	Issue Type +	Ma	Location *	LS
Category	Earthen Levee			GPS Latitude/Longitude	
				Start	End
Item	Trim / Thin Trees			37.817187 °	37.817187 °
				-121.352964 °	-121.352964 °
DWR ID	DWR_RD0544_02_f_2014_53				
Comment Code					
T2 : Thin trees to allow visibility of the ground and room to flood fight.					
Inspector Comment

Looking southwest at untrimmed tree on landward slope fall 2015.

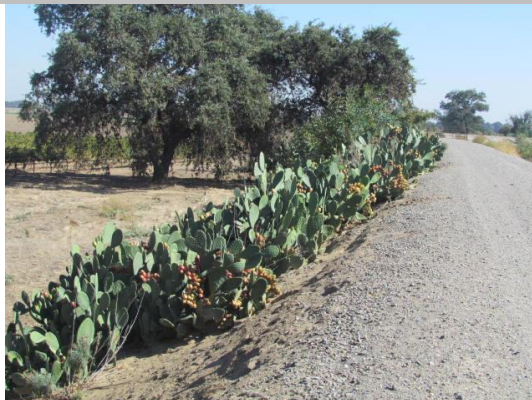
Photo 1 of 3 : FA\_2016\_RD0544\_109\_36\_20160929\_00035.jpg

LM Start	3.48	Rating **	U	Issue No.	36
LM End	3.51	Issue Type +	Ma	Location *	LS
Category	Earthen Levee			GPS Latitude/Longitude	
				Start	End
Item	Vegetation			37.819576 °	37.819530 °
				-121.364056 °	-121.364653 °
DWR ID	DWR_RD0544_02_s_2012_36				
Comment Code					
V2 : Remove the wild growth other than native grasses from the levee slopes.					
Inspector Comment					
Cactus on landside slope.

Looking northwest at cactus on landward slope and toe fall 2015
